Above Pictures of Elbows removed from service. 2" Sched XXH and 3' Sched #80 Elbows. 2-Sour Service Installations.

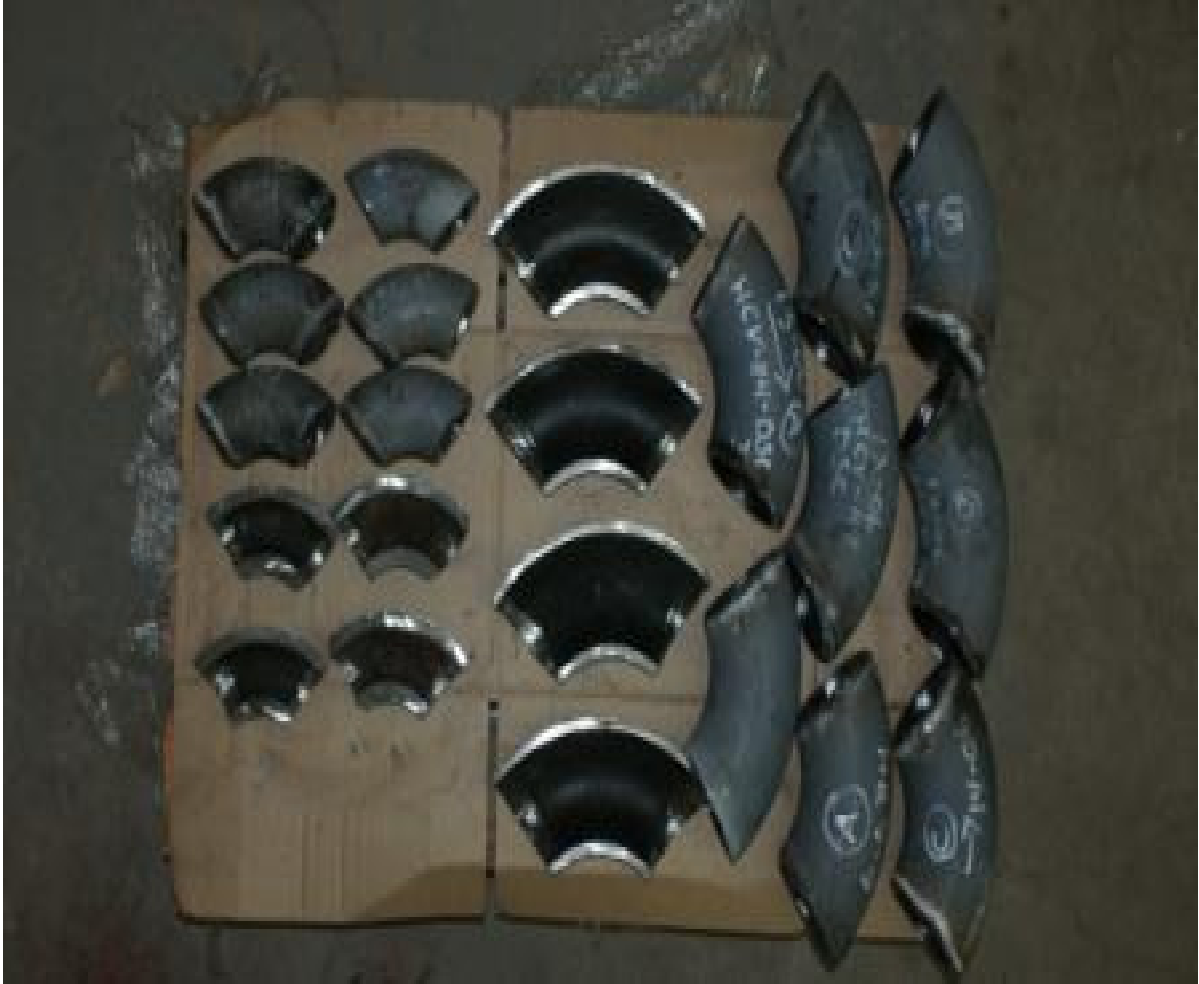
Wear was approx. 0.25 percent on Elbows

Elbows were in service approx 1 month.

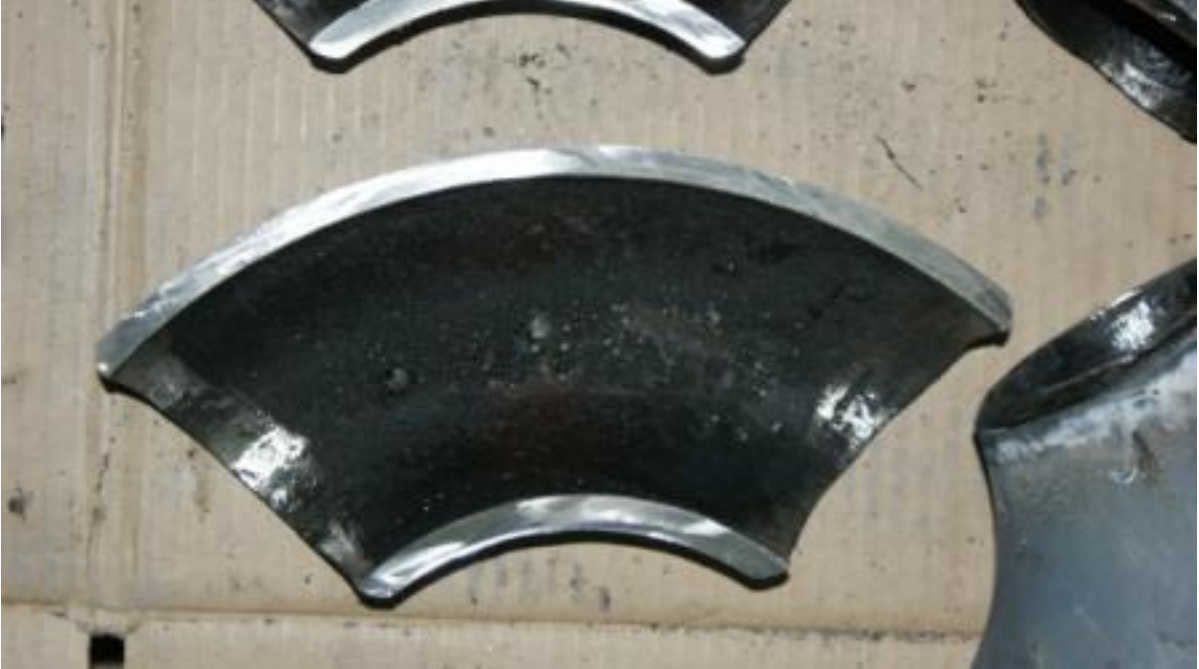
3"Schd#80 has a wall thickness of .300  
Cut 3" Elbow Outer wall measures .280 Wall thickness.

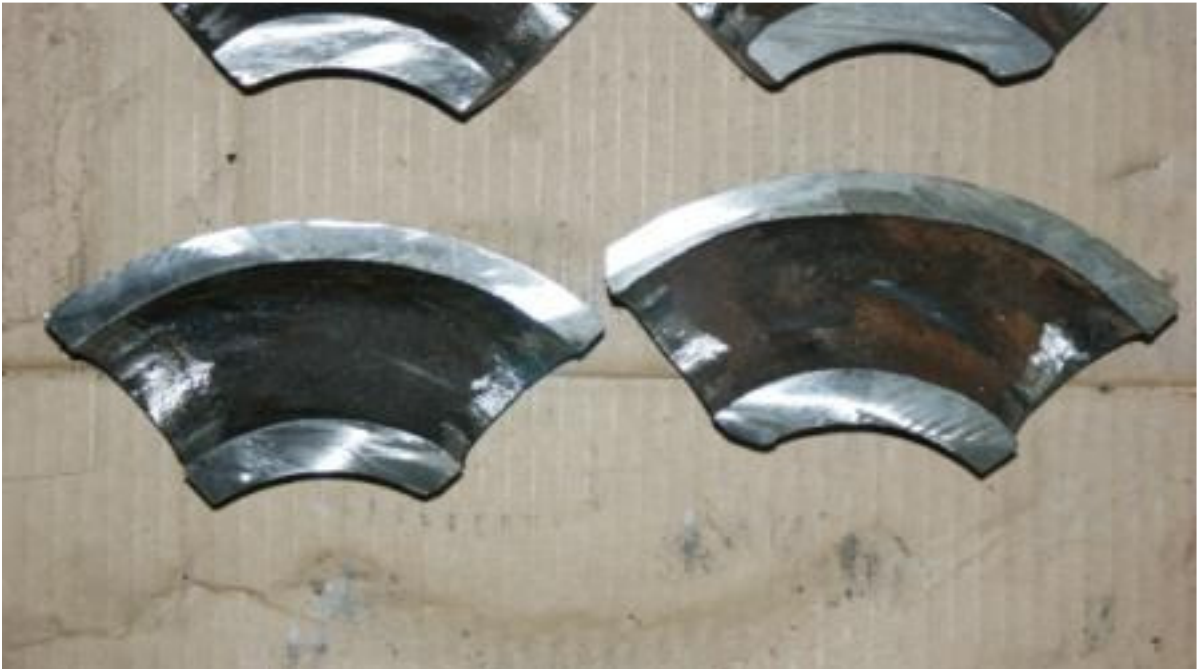
2" Schd#xxh has a wall thickness of .436  
Cut 2" Elbow Outer wall measures .400

Company could possibly save on Lost Time of production and replacement cost by switching to a system that would give them complete wear.

Our Product could give that and also have the pressure rating of a new elbow giving the operator the needed time to plan an Engineered shut down instead of an Emergency shut down.

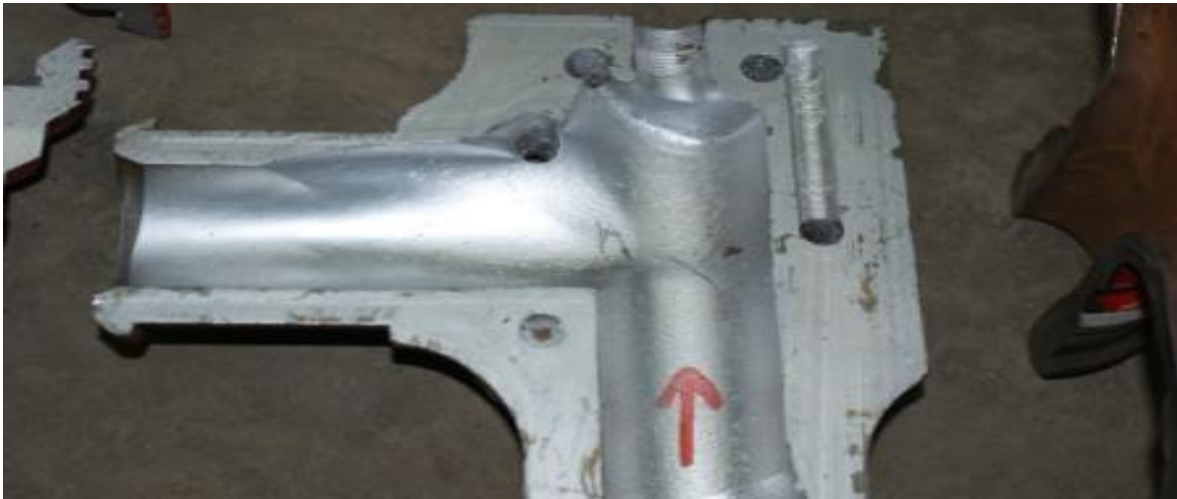
Washed Early Warning Elbow. Still protected. No Release.
