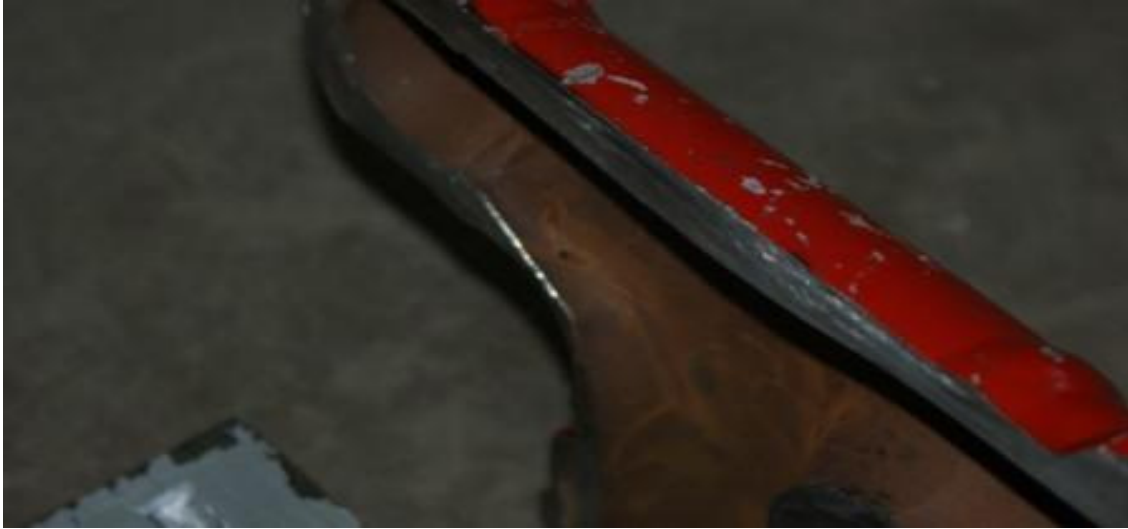
Washed Conventional Elbow “To Atmosphere”. Well shut in immediately. 5000psi Fitting / First Elbow off Well-head While performing coil-clean-out.

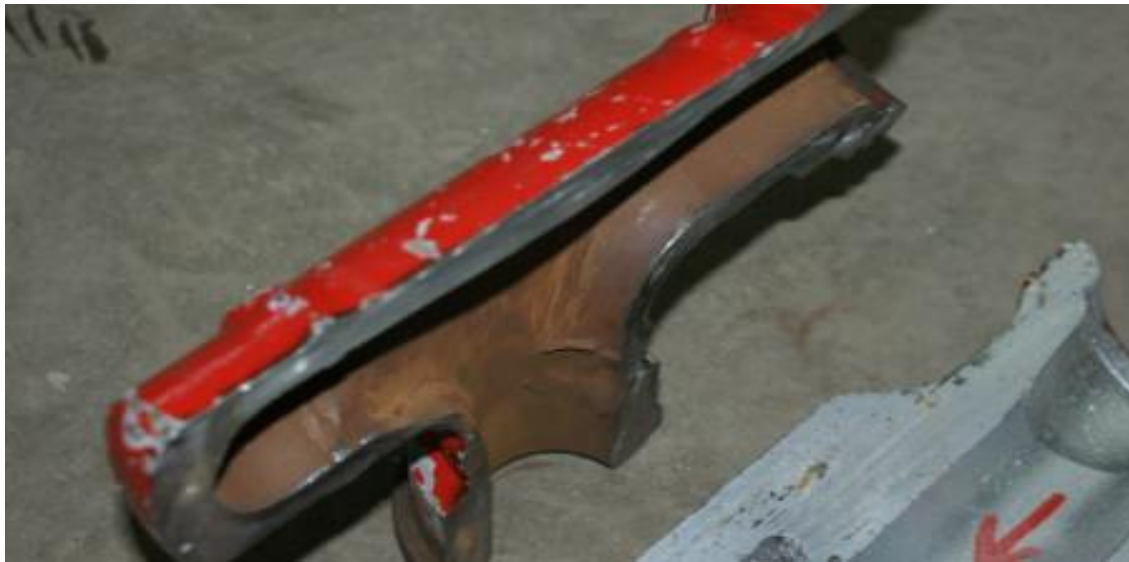
Bottom view of Conventional Elbow Above. Wear also occurred on bottom half of Elbow. Thinning all around Elbow

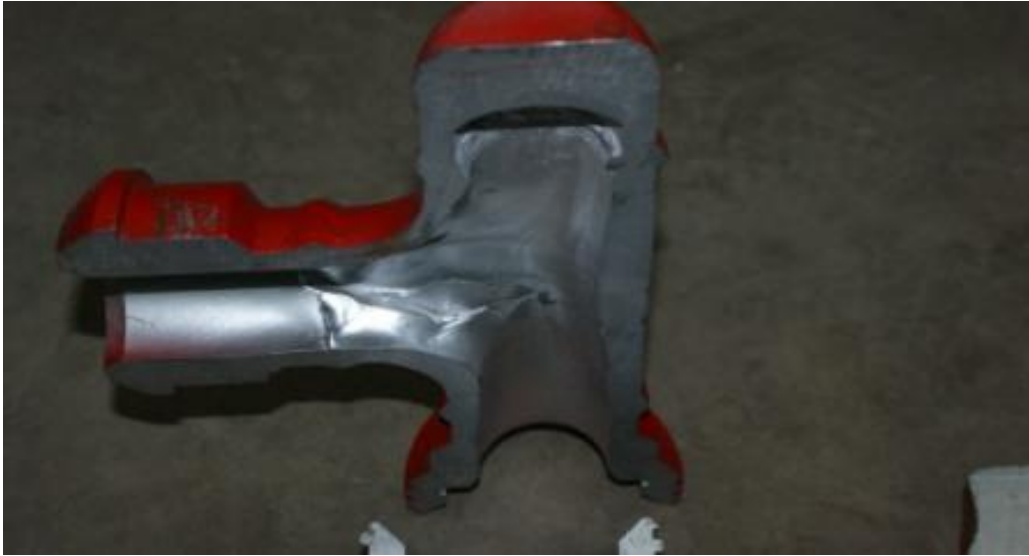
Aggressive wash present on this 5000psi Conventional Elbow. Elbow spotted during Shut-down. Immediately removed from service.

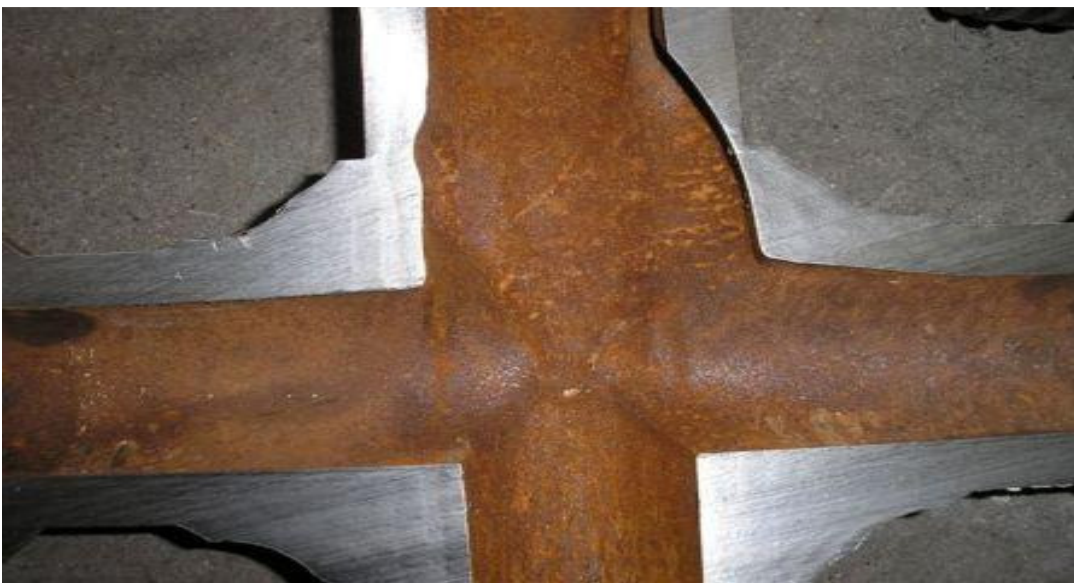
Washed Conventional Cross. 10000psi rating. Washed to Atmosphere. Wash pattern similar to that of an Elbow. Flowing from left to right. Sand cushion length seems to have not to made a difference in wear pattern.

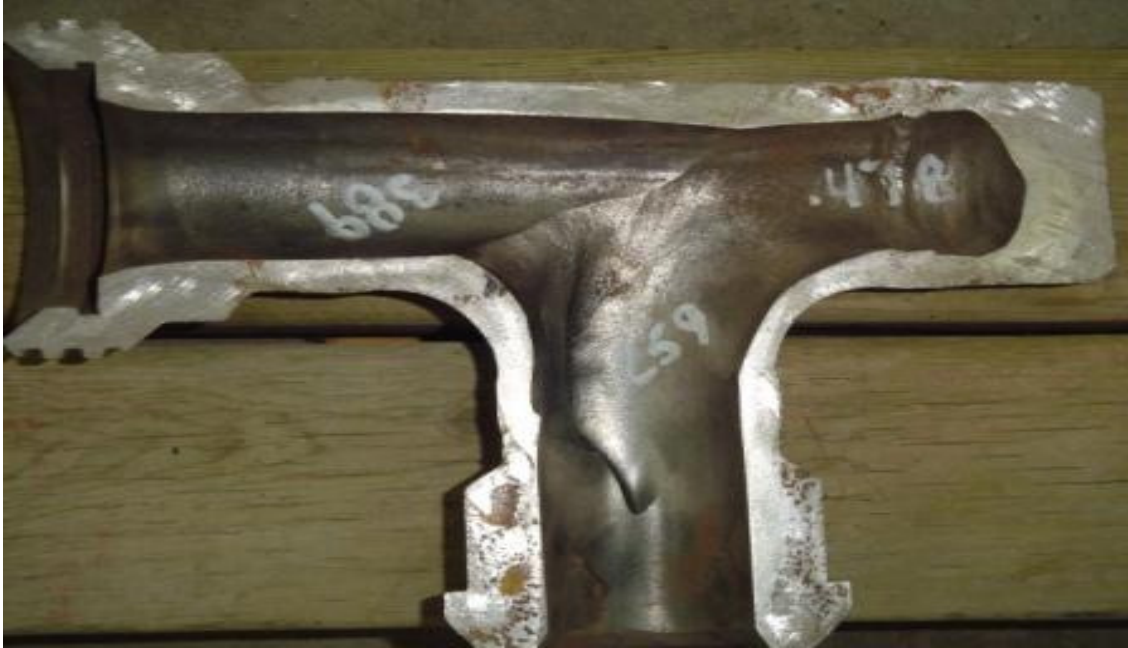
Another Conventional 5000psi fitting. Sand Cushion damage minimal. Again showing wear on both Bottom and Top side of Elbow

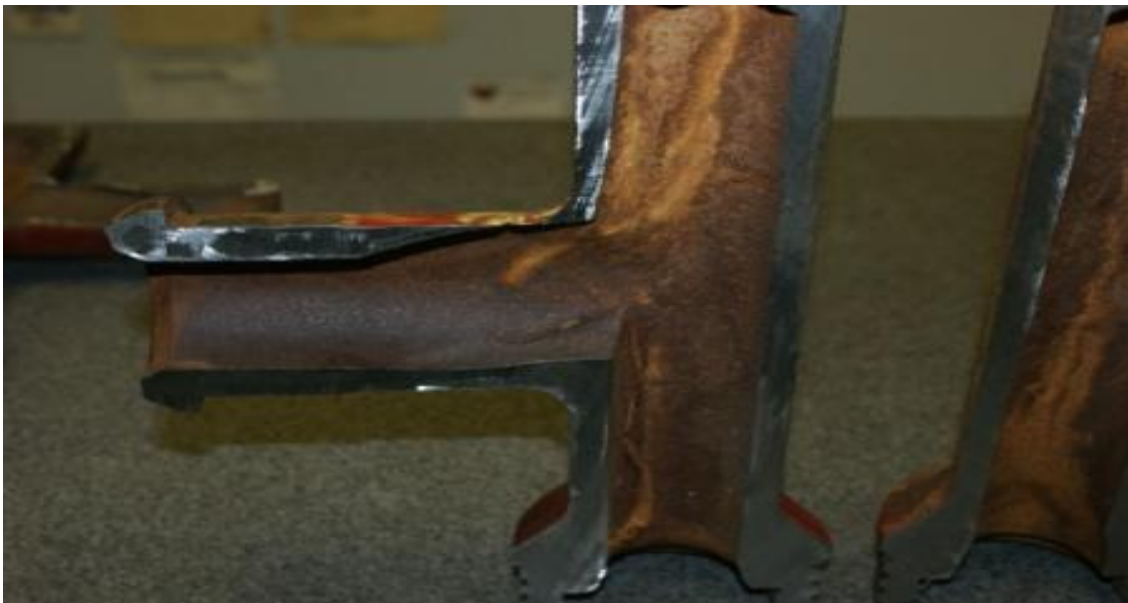
Washed Integral Elbow 5000psi. Wear Patterns are the same as Conventional Elbow. Washed to Atmosphere.

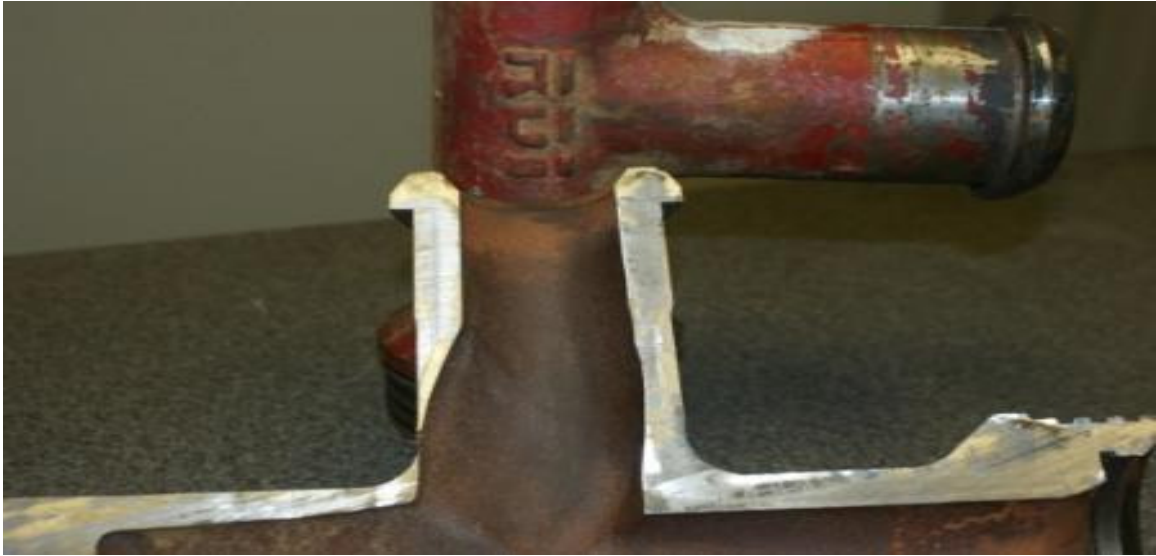
Washed Integral 5000psi fittings. Wear patterns don't seem to change with length of Sand Cushion. Still fittings are washing to Atmosphere.
