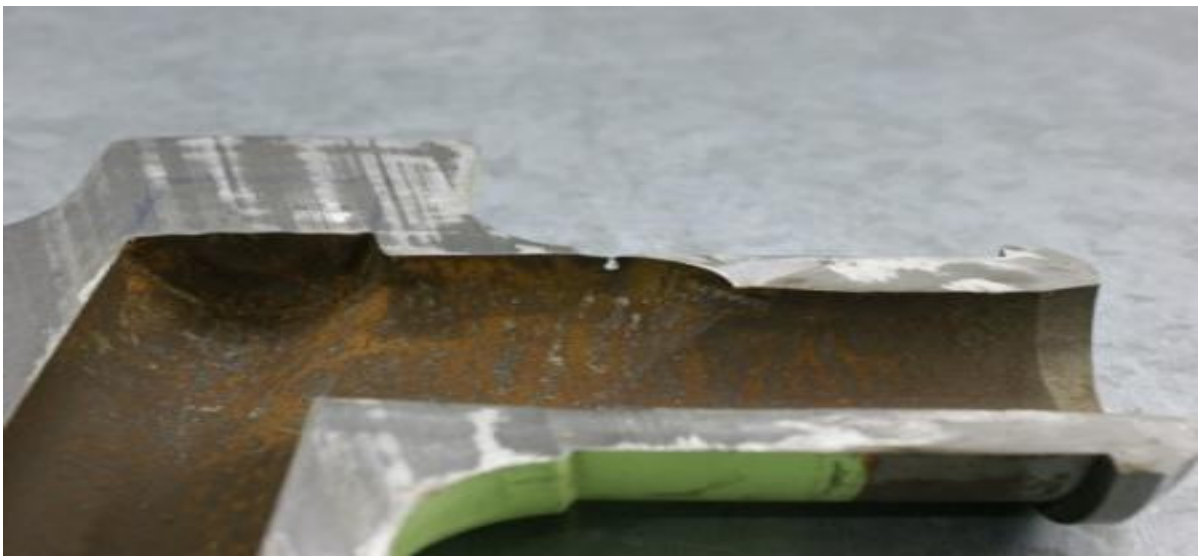
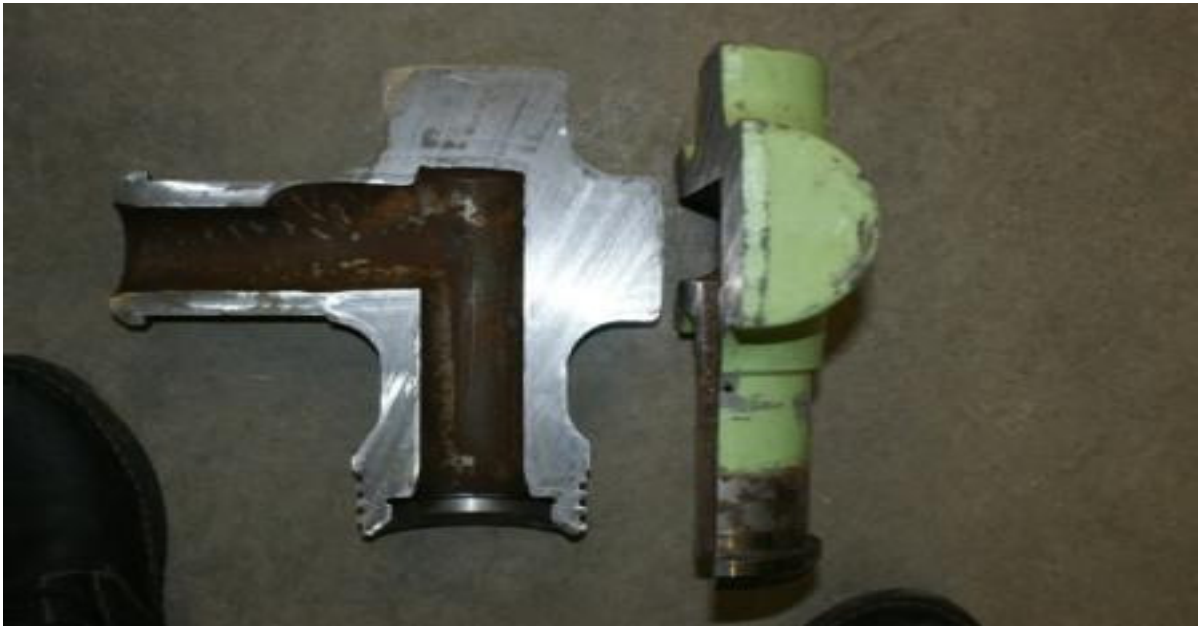
Worldwide Matrix Early Warning System. We don't claim to be able to stop the wash. We just want to warn Operators of impending Wash-out before release to Atmosphere.
